Five-Year Review Report

Third Five-Year Review

Hagen Farm Superfund Site

Town of Dunkirk, Wisconsin

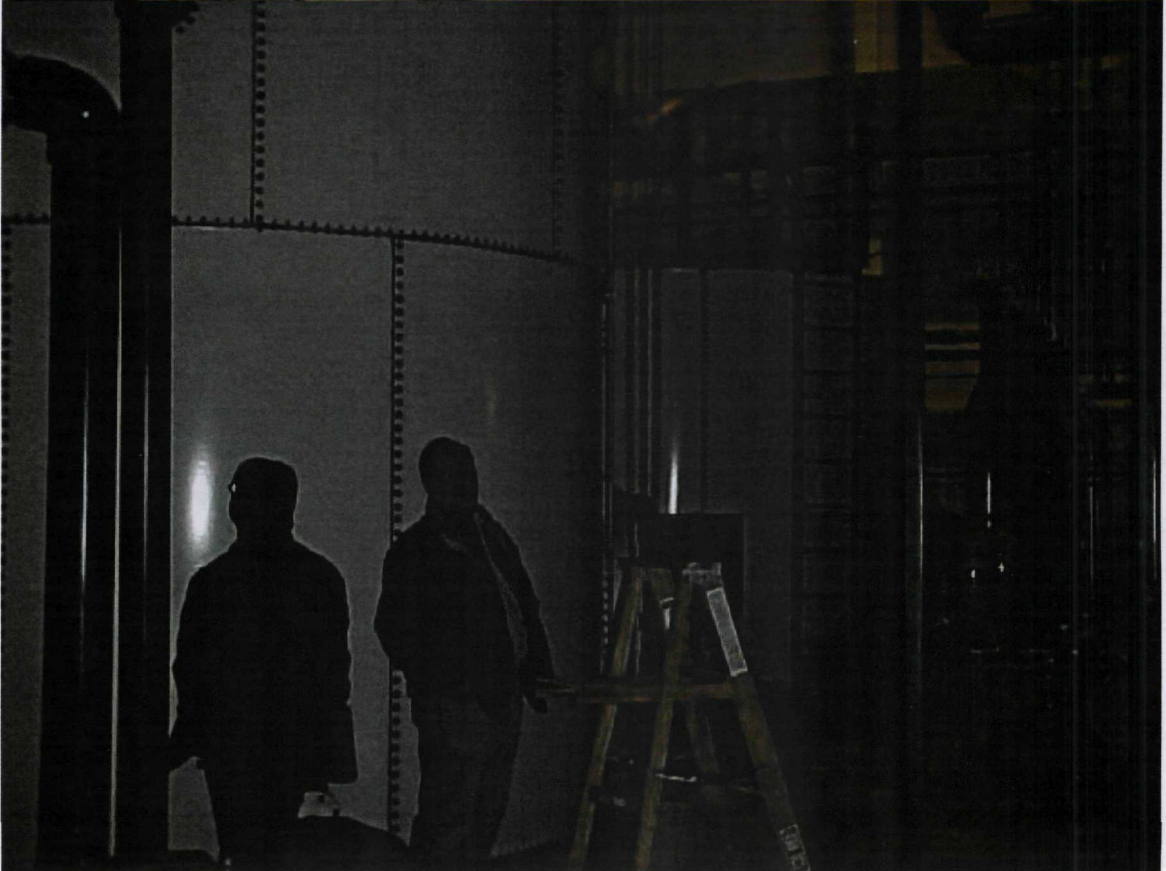
(18)

18. Treatment tanks for inactive groundwater treatment system
19. Treatment tanks for inactive groundwater treatment system
20. Entry gate sign
